## TEST REPORT

No. : 1 / 2017

Test item : **Self-supporting railing  
- impact resistance acc. to ČSN 74 3305**

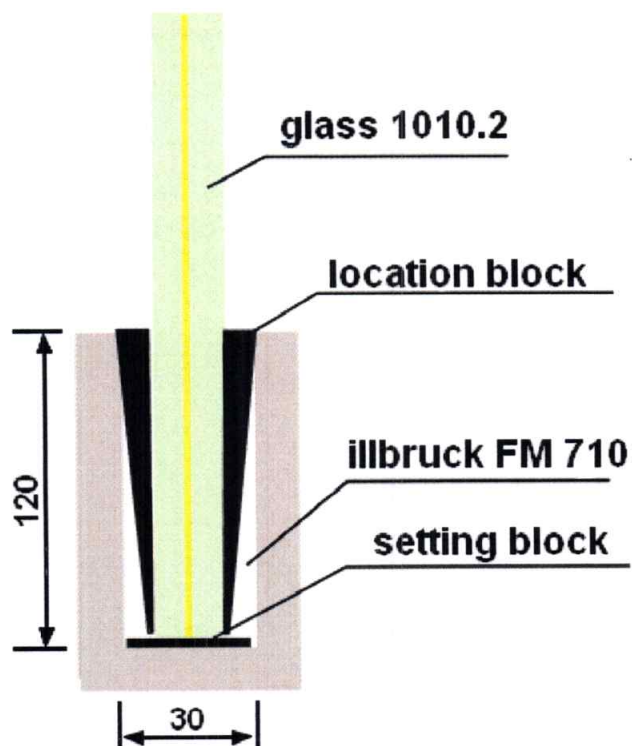
Scheme of mounting the glass into the U profile

Laminated safety glass: 10 mm float glass + 0.76 mm PVB foil + 10 mm (1010.2) float glass with dimensions 985 mm x 1000 mm fastened by gluing into the steel U profile (see sketch) using the illbruck FM 710 mounting foam.

The U-profile itself is attached to the concrete structure by means of four metal anchors. The wall thickness of the U-profile is 8 mm.

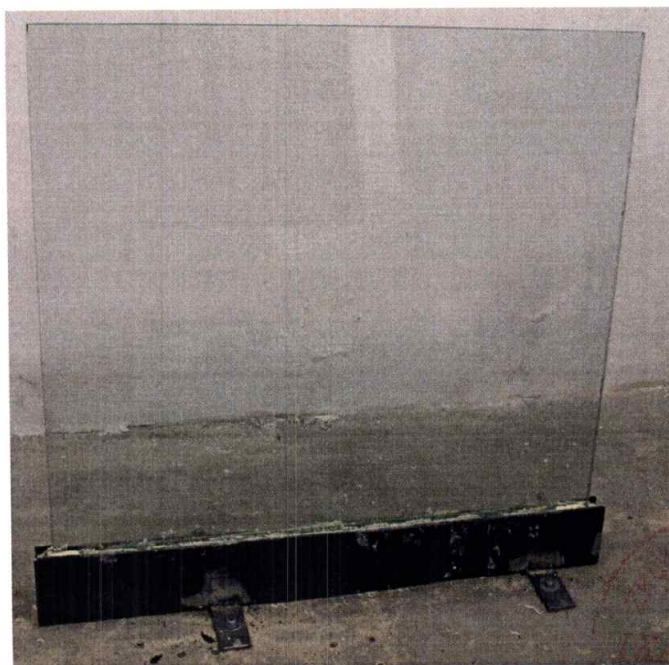
Sample	Impact point	State after the impact with energy
		150 J
sklo 1010.2 glued into U-profile	upper corner	no damage

Location of the impact point „upper corner“ is 200 mm from upper and vertical edges.

Pre-treatment of the sample (deliberated damage of the glass pane on the impact side) is not considered to be a damage of the sample (by the impact).

**Conclusion:** The tested sample of railing complies with the requirements of ČSN 74 3305 for the impact test for areas with low and normal traffic.
